TELEDESIC BROADBAND CENTER FIELD STUDY

SUMMARY REPORT
APRIL 2002

CENTER FOR THE
BUILT ENVIRONMENT

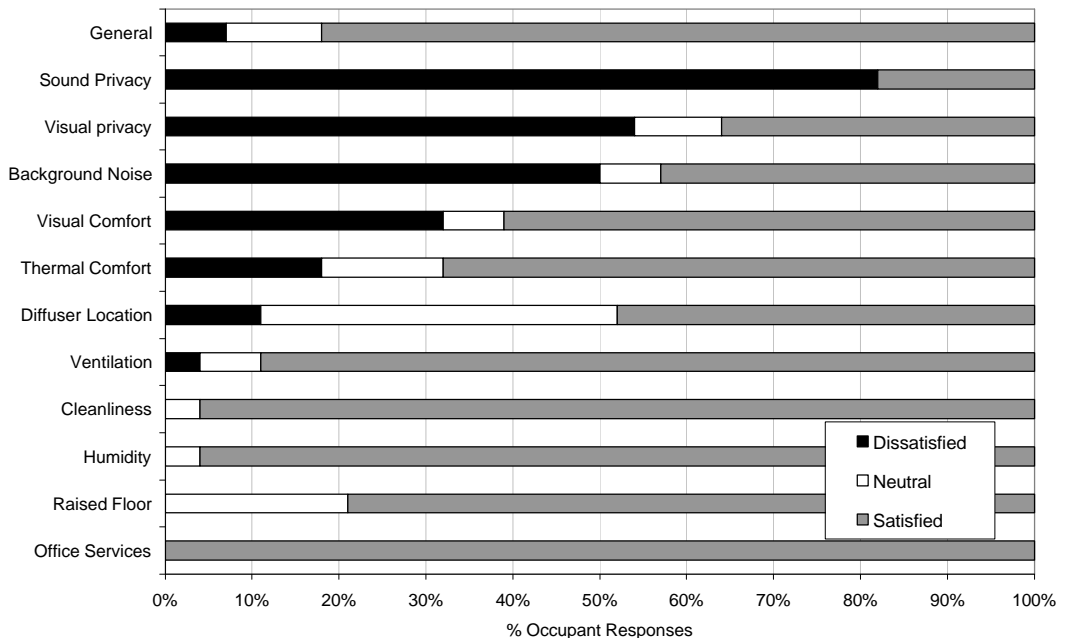
Figure 1.1
Occupant satisfaction
survey results

It is apparent from this study that from a thermal comfort point of view the building performs very well in wintertime. However, responses from the occupant satisfaction survey tell us that the flexibility of the UFAD system is not being exploited by occupants in a way that could increase the overall satisfaction level.

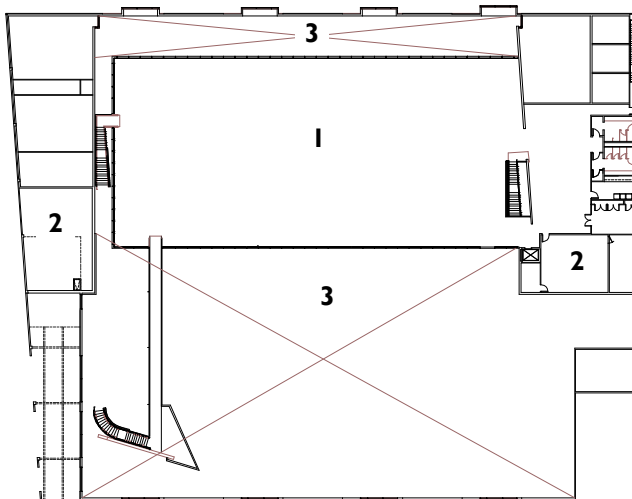
Figure 2.1
Building section

- 1 Open office area
- 2 Mezzanine
- 3 Conference and work rooms

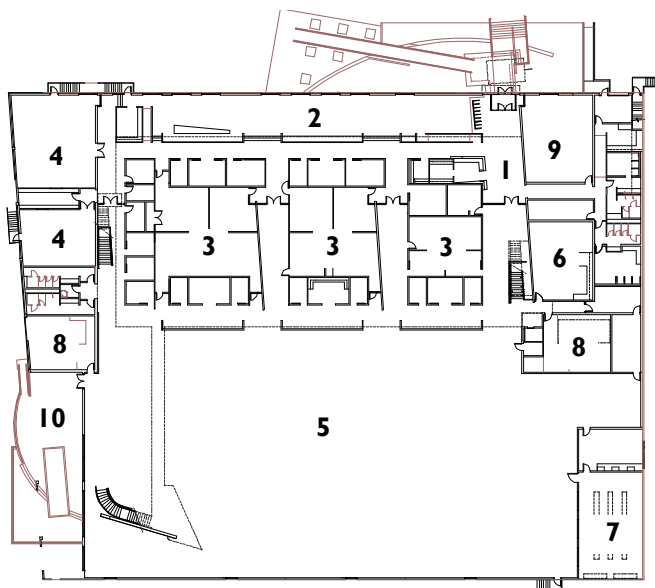
Figure 2.2
Mezzanine level plan

- 1 Mezzanine open office area
- 2 Mechanical
- 3 Open to below

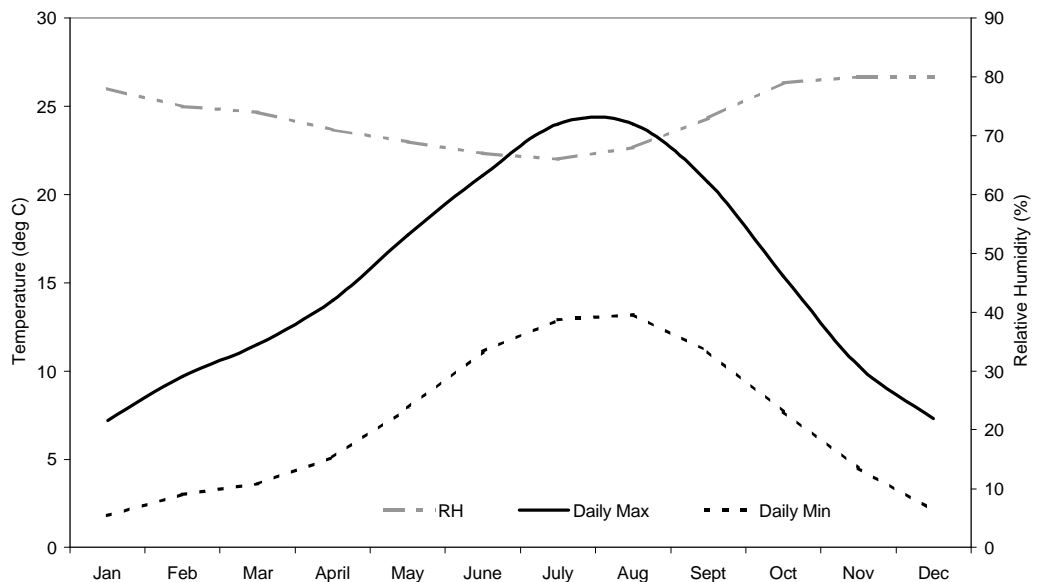
Figure 2.4
Temperature
maximums and
relative humidity for
Seattle-Tacoma region

Figure 2.4 presents climate data for the Seattle-Tacoma region and indicates the nature of Teledesic's climatic context. An analysis of heating and cooling degree-days reveals that winter conditions clearly predominate for the majority of the year.

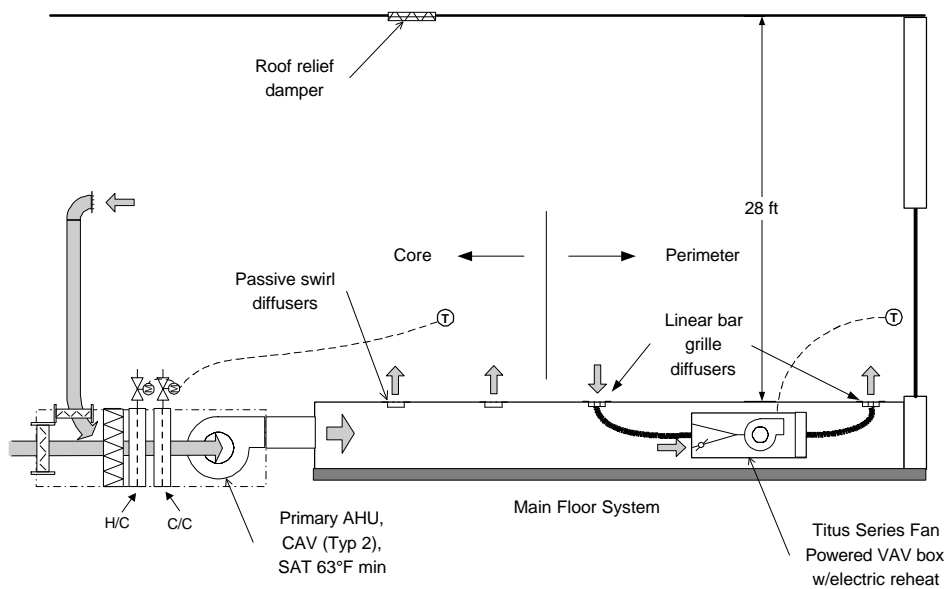
Figure 2.6
Underfloor system
schematic, south open
office area

In the north perimeter zone, cool plenum air is distributed through linear diffusers located in the kick-plates of the cabinets. These diffusers incorporate a two-position damper that minimizes plenum air delivery during heating. Finned tube convectors located along the exterior wall provide heating for this zone.

Other perimeter zones operate as CAV-VT systems with the use of variable air volume (VAV) fan-powered mixing boxes. During intermediate load conditions, room air is drawn into the plenum through linear diffusers, mixed with fresh plenum supply air and re-emitted through diffusers at the perimeter of the zone that are connected to the mixing box via flexible ducts. Although each zone operates as CAV system, for the system overall the supply air volume varies to some degree as the fan-powered boxes reduce the percentage of plenum air used. In winter, the percentage of plenum air used is the minimum necessary to satisfy fresh air requirements, with re-circulated room air comprising the majority of the volume of supply air.

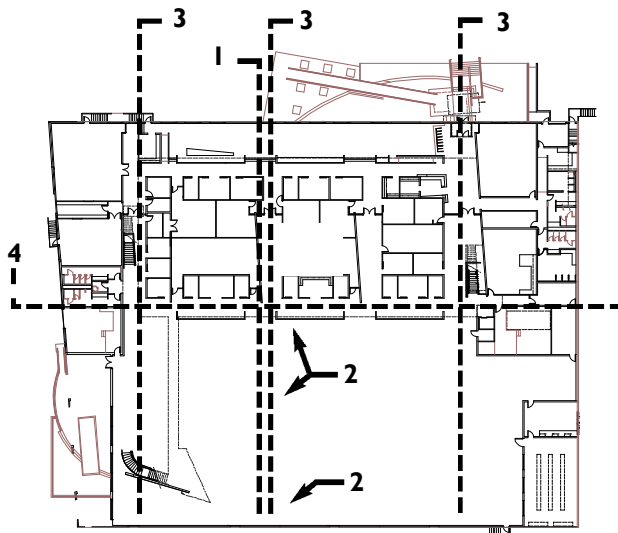
Figure 3.1
Data collection locations

- 1 Diffuser temperature data collection line
- 2 Thermal stratification data locations
- 3 Room air temperature data collection lines
- 4 Sound level data collection lines

The investigation team was interested in monitoring supply air temperatures to establish relationships between room air and supply air temperatures in order to study thermal decay. Data loggers were placed in floor diffuser baskets at 20 locations on the ground floor and mezzanine. The locations were chosen to obtain a range of different plenum conditions, such as next to fan terminal units, in the perimeter zones, or in core areas. To compliment this temperature monitoring, spot measurements of the air velocity and sound pressure level were taken, both within and immediately above each floor diffuser containing a data logger. A complete list of field measurements is summarized in Appendix 1. The locations for data collection are shown in Figure 3.1.

ducts and through the open plenum. Diffuser temperatures were recorded from the mechanical room northward and southward along line "1" shown on Figure 3.1. Supply air temperatures in both north and south zones are highest approximately 20-30 ft (6-9 m) in from the external wall and lowest in the perimeter areas. The temperature differences are relatively small, all within 2°F (1.1°C) of one another. These variations are relatively small, especially when considering the accuracy of measurements. It is also not clear to what effects air flow patterns (e.g., dead spots) in the plenum might have on diffuser supply air temperatures.

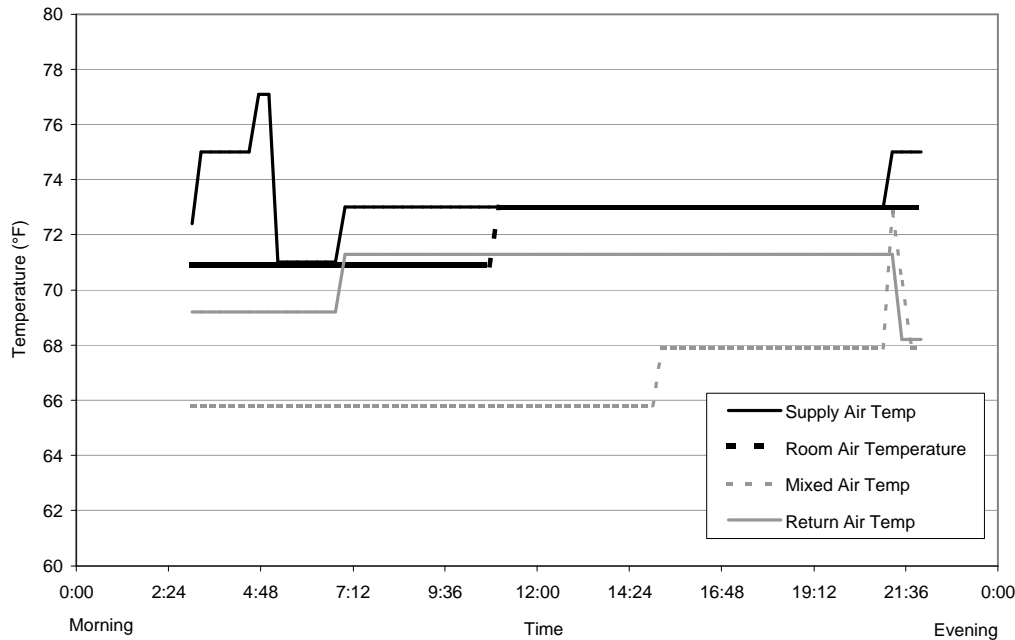
Figure 4.1
Temperature profiles
under winter day
operation

As illustrated in Figure 4.1, heating occurs during winter operation from a mixed air temperature (MAT) of 66-68°F (18.8-20°C) to a 71.5°F (21.9°C) supply air temperature (SAT). The temperature increases to 73°F (22.7°C) in the room followed by a drop to 71.5°F (21.9°C) at the return. The reason the return air temperature is cooler than room air may be due to the cooler supply air temperatures at the mezzanine level, as explained earlier. The outside temperature was in the range of 30-40°F (-1-4°C) during the day represented in this graph.

On a typical winter day additional heating of supply air is not required for the main floor internal zone since a supply air temperature of 71.5°F (21.9°C) is adequate to maintain the zone set-point of 73°F (22.8°C).

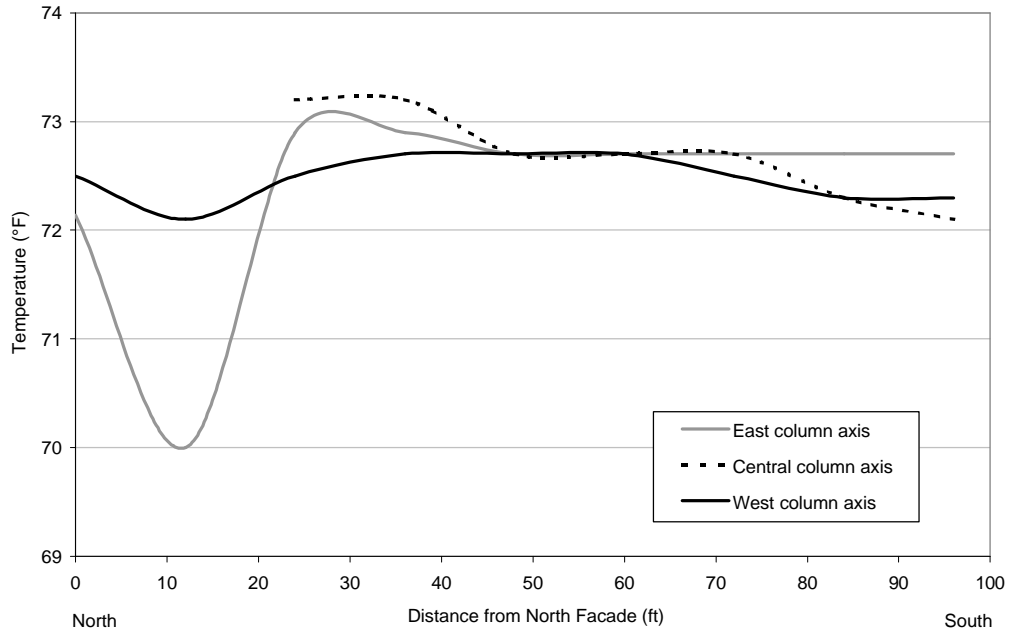
Figure 4.4
North-south variations in room air temperature

To document room air variation throughout the building, measurements were taken with hand held devices at 4 ft (1.3 m) above the floor level from north to south along three lines within the building, as shown in Figure 3.1. The readings are illustrated in Figure 4.4. The noticeable dip in room air temperatures to the north occurs within the glazed entry area. This temperature drop is due to the combination of northern exposure, fully glazed entrance doors that are frequently opened, and minimal internal gains from intermittent occupancy. (The receptionist seated in this area has installed a large portable electric heater.) Passing through the glazed doors separating the entry

from the main workspace area there is a perceptible temperature difference. However within the main workspace area variations in room air temperatures are within about 0.5°F (0.28°C).

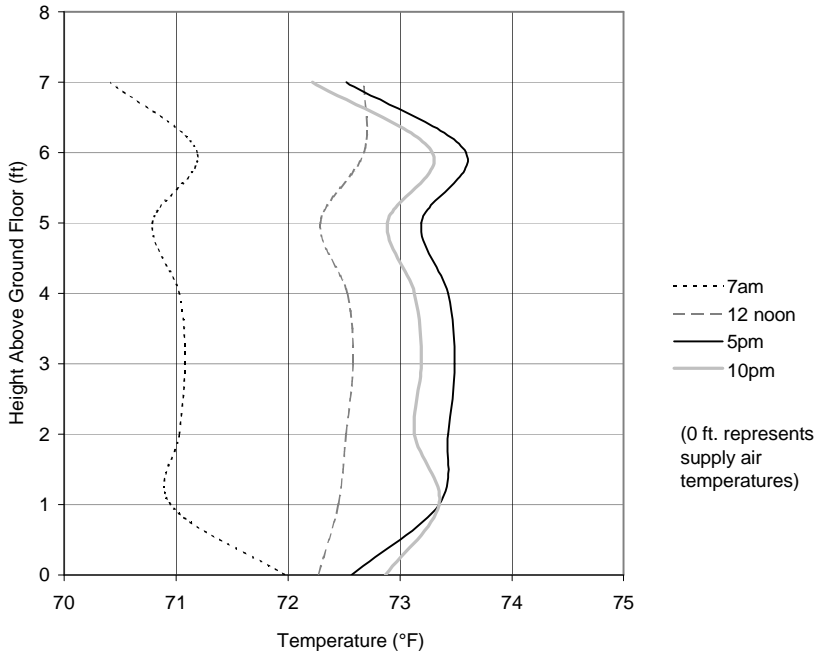
Figure 4.5
Vertical plane temperature profiles over the working day

Comparison of the data from the two strings of data loggers show that the internal zone was generally 2°F (1.1°C) higher than those recorded in the south perimeter zone. This difference is expected since the perimeter zone is operating at its heating set-point [70°F (21.1°C)] and the internal zone is operating at its cooling set-point (estimated to be 73°F (22.8°C)). Internal gains in the interior and potential fabric heat loss in the perimeter zone cause these temperature differences. The magnitude of this difference is more pronounced as temperatures fall during the evening, and are less during the working day.

Analyzing the entire data set as a whole, Teledesic's internal environment appears to be that of environmental uniformity within and between zones (south, east, west, and mezzanine), except for the north zone where temperatures are somewhat lower due to the proximity of the front door, low internal loads, and significant heat losses.

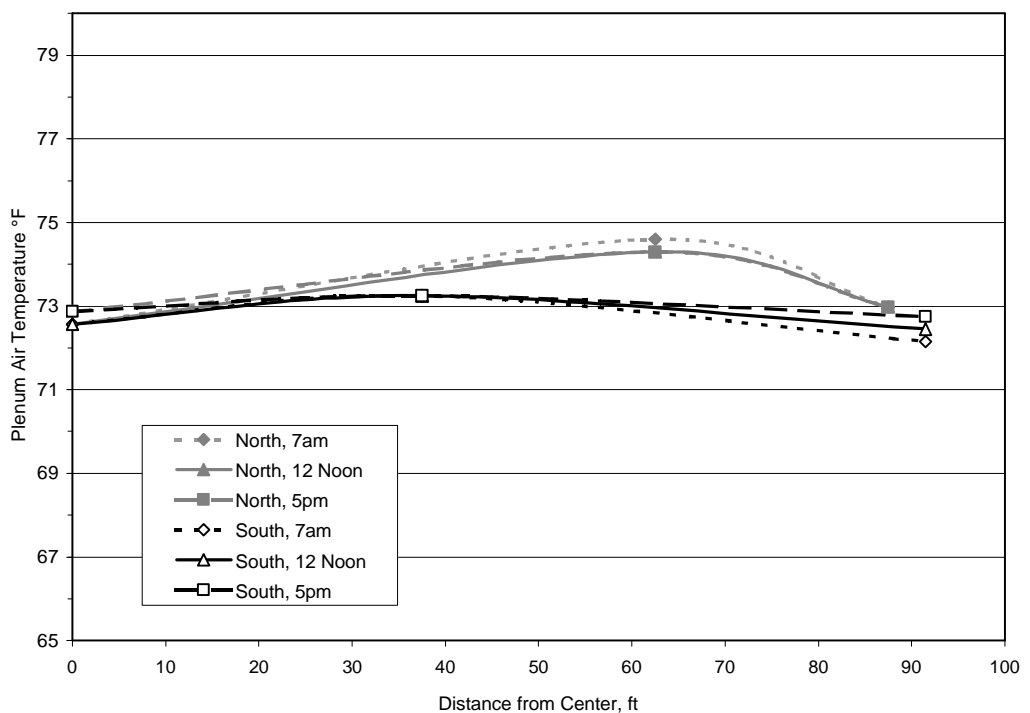
Figure 4.6
Thermal decay of supply air with distance from the AHU

Figure 4.6 shows the relationship between the supply air travel distance and the temperature recorded at that diffuser. This distance includes the total length through

Thermal transfer between cool supply air and a warmer slab typically leads to an increase in supply air temperature en route from AHUs to diffusers during cooling mode. The fact that the slab temperatures vary little throughout the year and an observed decrease of only 1-2°F occurs during winter suggests that thermal decay will not be significant in the summer cooling season.

During the design stage of Teledesic, the mechanical design addressed the risk of thermal decay (undesirable changes of supply air temperatures) throughout the under-floor area. Potential surfaces for thermal transfer included the ground floor slab, the raised floor, and return air ducts. The system was designed with ducts running from the AHUs below the ground floor plenum to supply stub ducts within the plenum that run in a north-south direction. Insulated air highways are used in the mezzanine level. To avoid sub-dividing the plenum attention was paid to defining the maximum possible distance between a discharge duct and floor diffuser before thermal gradients became problematic. Based on previous experience and calculations carried out by Arup, the maximum discharge duct-to-diffuser distance was established as 50 ft (15 m) to ease concerns of long-term temperature problems.⁷

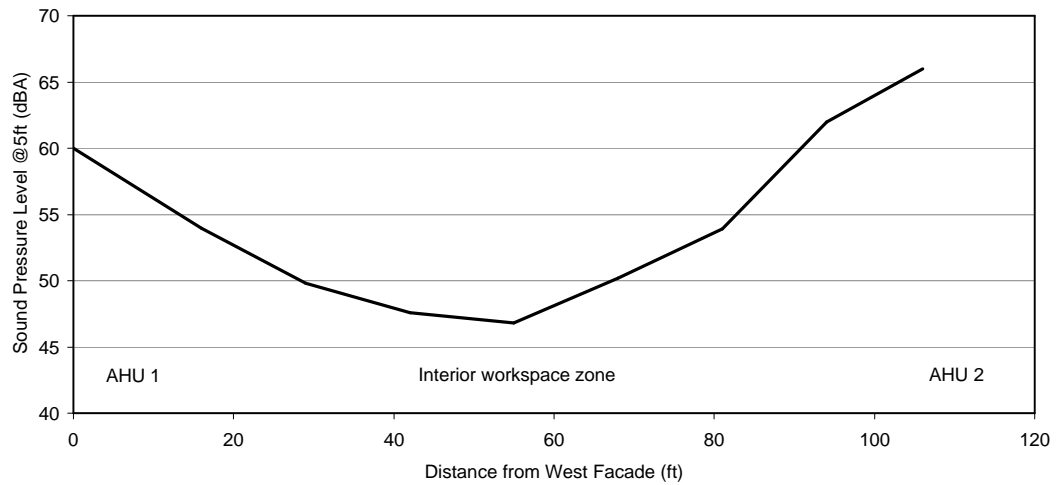
Figure 4.8
Ambient sound level readings

Figure 4.8 shows sound level profile measured in the ground floor open office area. These readings are considerably higher adjacent to the east and west AHUs. Comparisons with Table 4.3 show that the conditions near the equipment rooms were above the acceptable range of 50-55 dBA for open office environments. In the center of the space levels of 46 dBA were recorded, a level typical of private office environments. While taking measurements in the center of the open office area, researchers noted that the background noise level was so low that if a conversation was started at any location the readings increased considerably. This is consistent with occupant survey results which revealed a great concern that conversations could easily be overheard. This indicates that background noise may be too low in most places (most likely exacerbated by the low number of occupants) so that there is no masking effect to reduce the impact of individual conversations.

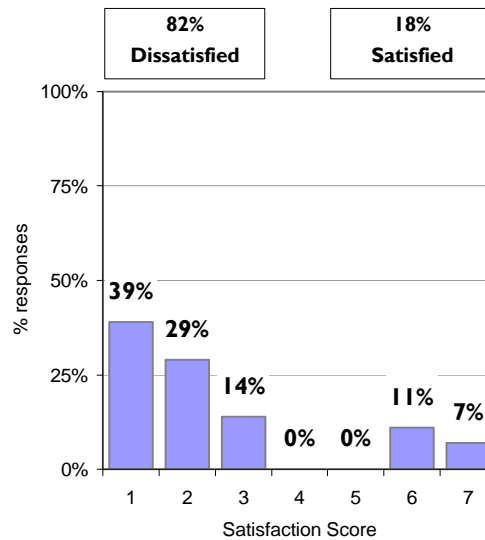
How satisfied are you with your sound privacy?

Sound privacy was also a significant cause of complaints, as illustrated in Figure 4.4. This dissatisfaction may have multiple causes, including the unexpected low occupancy resulting in lower masking background noise levels. The dissatisfaction may be partially based on expectations, for example one occupant missed the privacy of a private office. Any occupants that may have had private offices previously would certainly be dissatisfied from the adjustment to an open office environment. However, despite the high dissatisfaction rate for the acoustic environment in general, 50% of the occupants failed to identify the level of background noise as the source of their discomfort.
